PINE RIDGE SOLAR FARM

Visual Analysis

Location	Lot: 209, 219 and 270 DP750615 Cartwrights Lane, Wyalong NSW 2671	
Project Number	630.30642.00000	
Client	Providence Asset Group

SLR Ref No: 630.30642.00001.00000-v.04

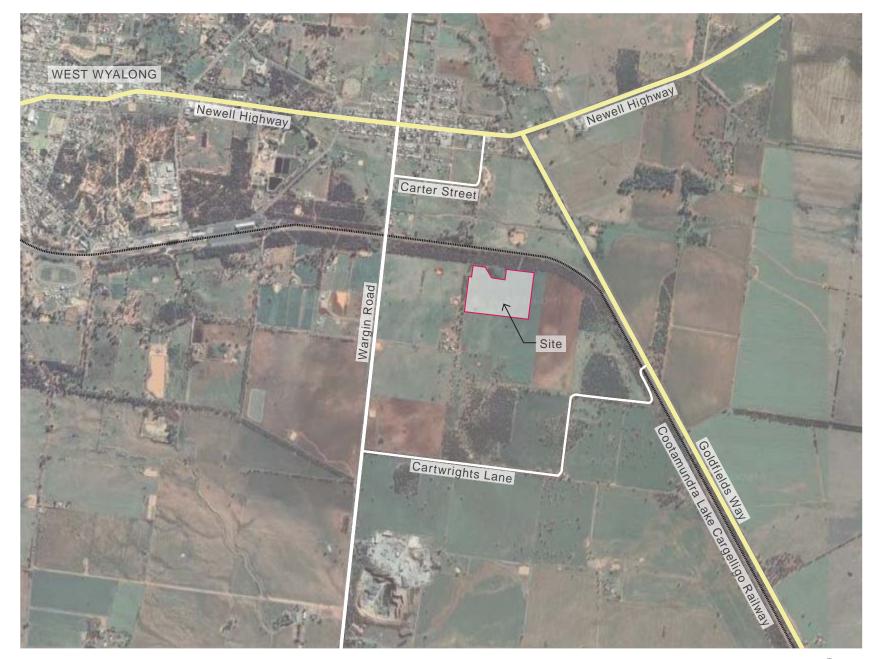
Figure 1. Locality Plan

The site is located to the west of Goldfields Way (B85) and south of the Newell Highway. The proposed development will consist of solar panels mounted on single-axis trackers connected to a power conversion station with an access and hardstand area from the existing track adjacent to the railway line. The development will be confined to Lot 209, Lot 219 and Lot 270, DP750615 (Figure 1).

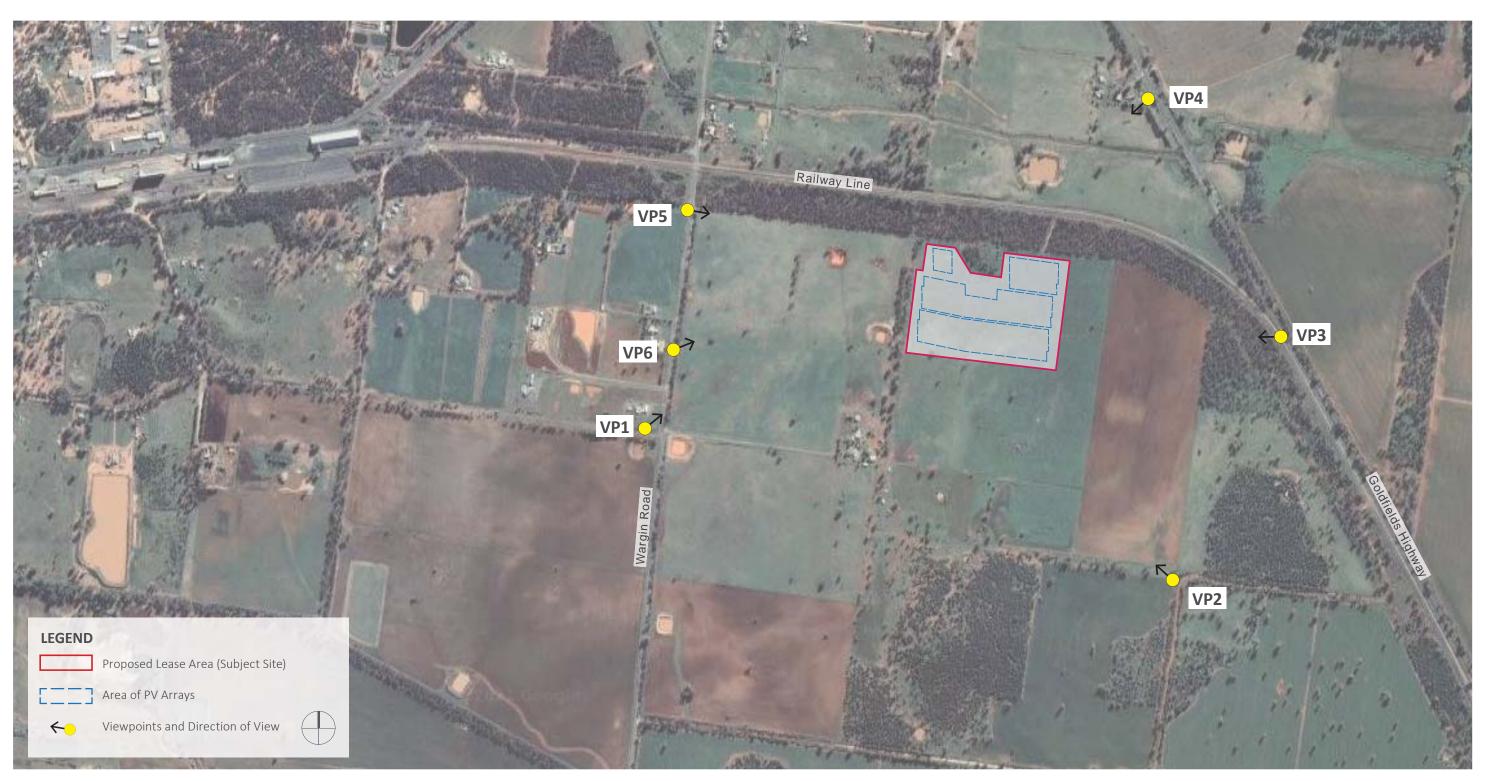
Figure 3. Selected Visual Receptors and Direction of View

Six representative viewpoints were identified where the site could be seen preferably from public locations. Due to the distances from the site, presence of topographic and vegetated features, surrounding structures and the limited views from publicly accessible areas, the choice of viable views was limited. The following sheets describe and rate the sensitivity of each viewpoint, the nature and magnitude of impacts likely to occur and the resultant significance of impacts for each receptor.

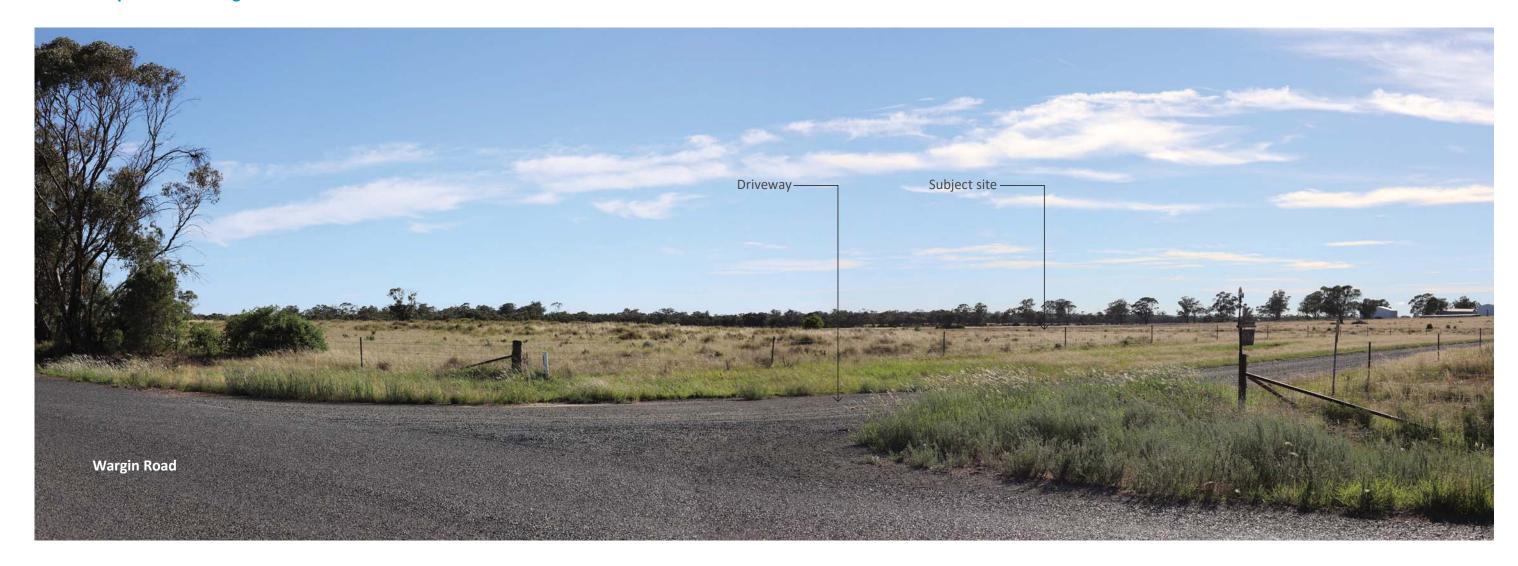
5.6.2 Viewpoint 1 - Existing

Receptor - VP1	Location	
Coordinate Location	33°56′27.018″ S 147°14′15.174″ E	
View Description	View looking north east towards the Solar Farm from Wargin Road	
Distance from Site Approx. 830m

- Rural landscape dominated by Wargin Road in the foreground.
- Vegetation along the road and northern edge of site terminates views from this viewpoint.

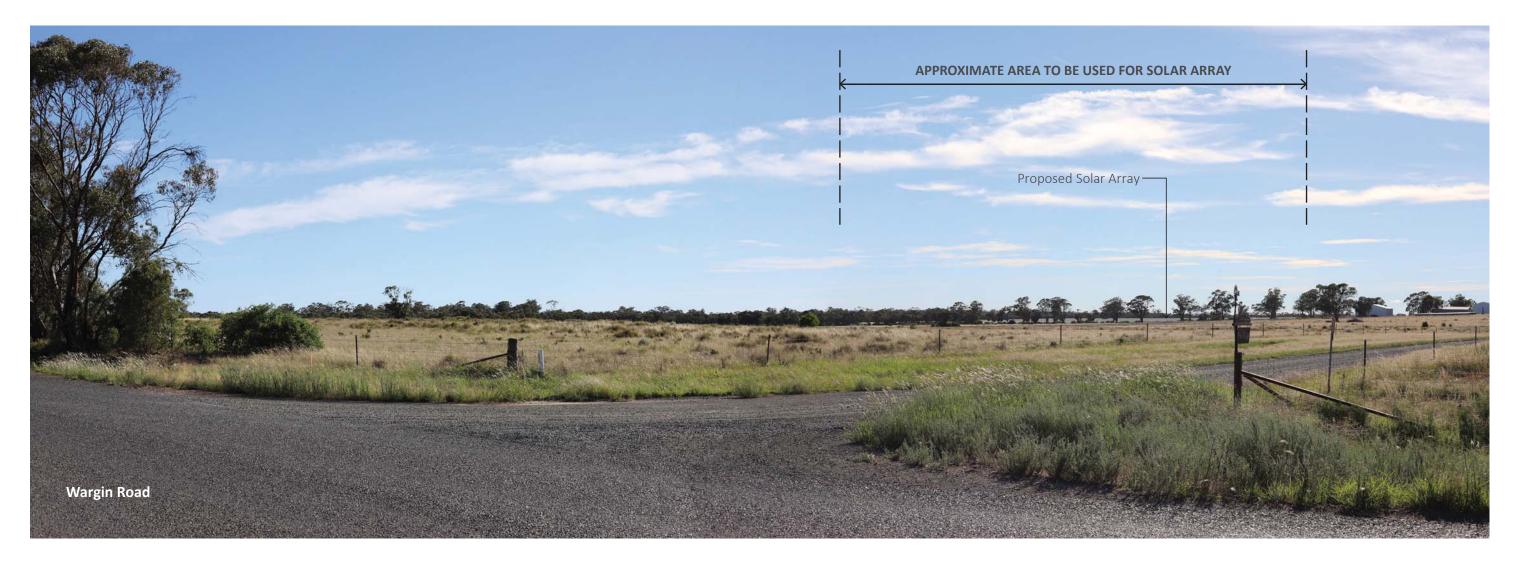
5.6.3 Viewpoint 1 - Proposed

Receptor - VP1 Summary of Impact Assessment		
Receptor Sensitivity	Negligible	
Magnitude of Landscape Change	Low	
Impact Significance	Minor - Negligible	
Mitigation Measures	From this viewpoint no mitigation measures are considered necessary.

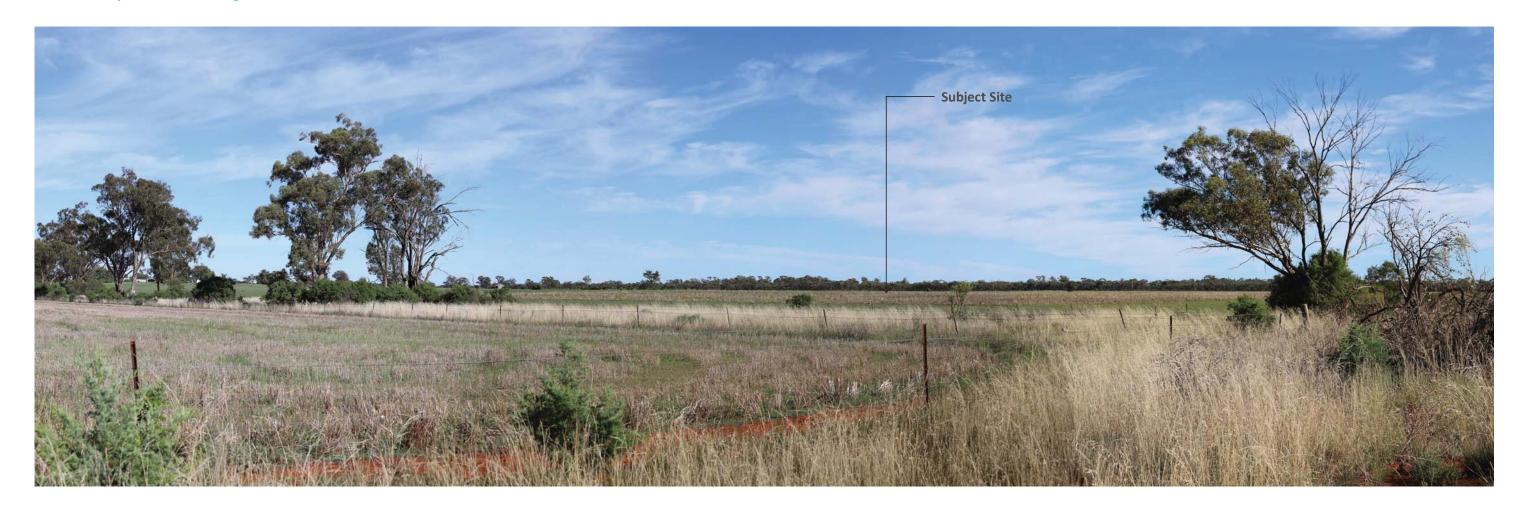
5.6.4 Viewpoint 2 - Existing

Receptor - VP2	Location
Coordinate Location	33°56′42.93″ S 147°15′19.2″ E
View Description	View looking north west towards the Solar Farm from Cartwrights Lane
Distance from Site	Approx. 750m

- Rural landscape dominated by open fields in the foreground.
- Vegetation along the northern edge of site terminates views from this viewpoint while vegetation along the fence and boundary lines breaks up open views.

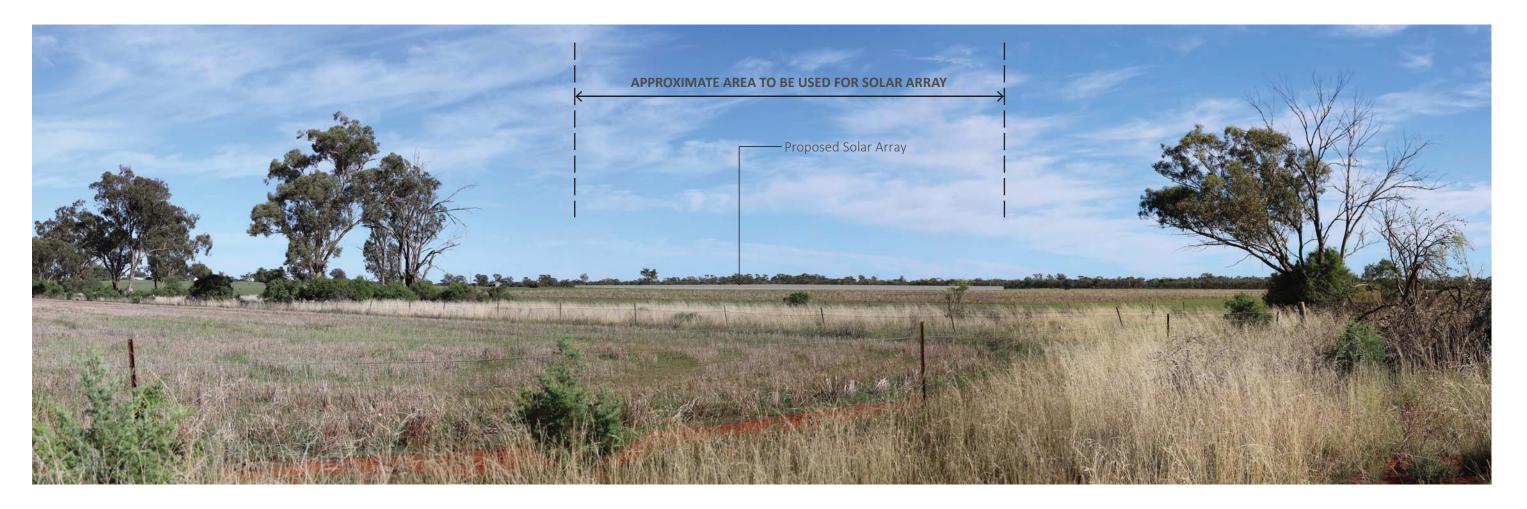
5.6.5 Viewpoint 2 - Proposed

Receptor - VP2 Summary of Impact Assessment		
Receptor Sensitivity	Negligible	
Magnitude of Landscape Change	Low	
Impact Significance	Minor - Negligible	
Mitigation Measures	From this viewpoint no mitigation measures are considered necessary.

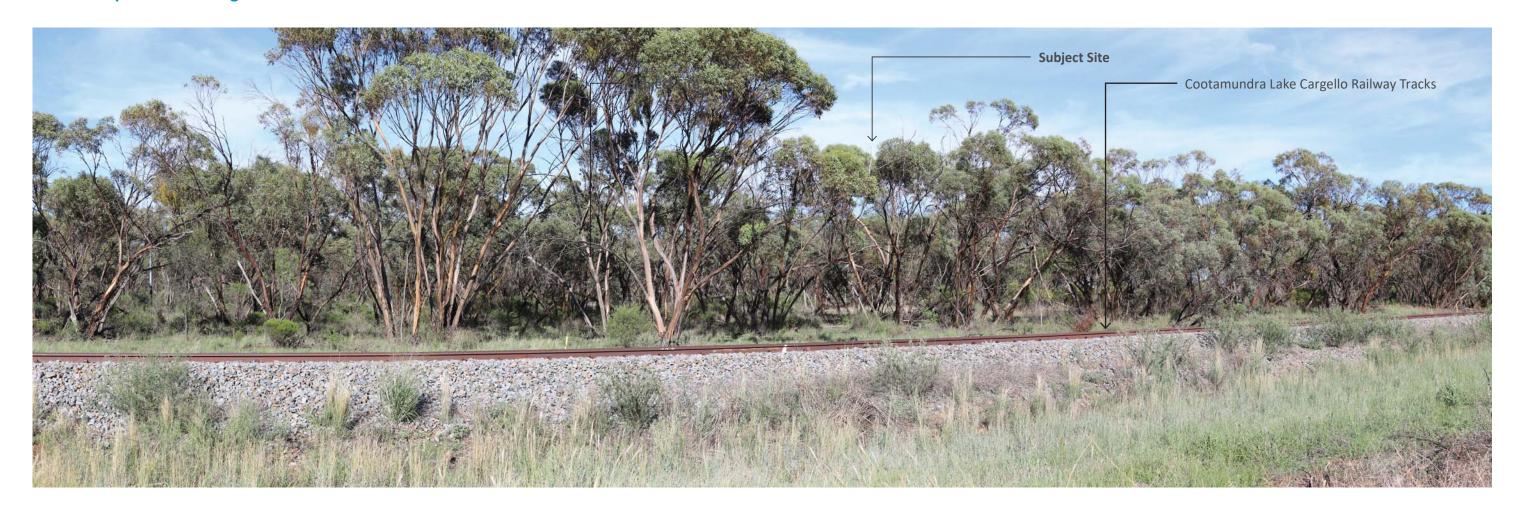
5.6.4 Viewpoint 3 - Existing

Receptor - VP3	Location	
Coordinate Location	33°56′17.652″ S 147°15′32.07″ E	
View Description	/iew looking west towards the Solar Farm from Goldfields Way	
Distance from Site	Approx. 680m

- Rural landscape dominated by the Cootamundra Lake Cargello Railway Tracks in the foreground.
- Vegetation along the Western side of the railway tracks terminates views from this viewpoint.

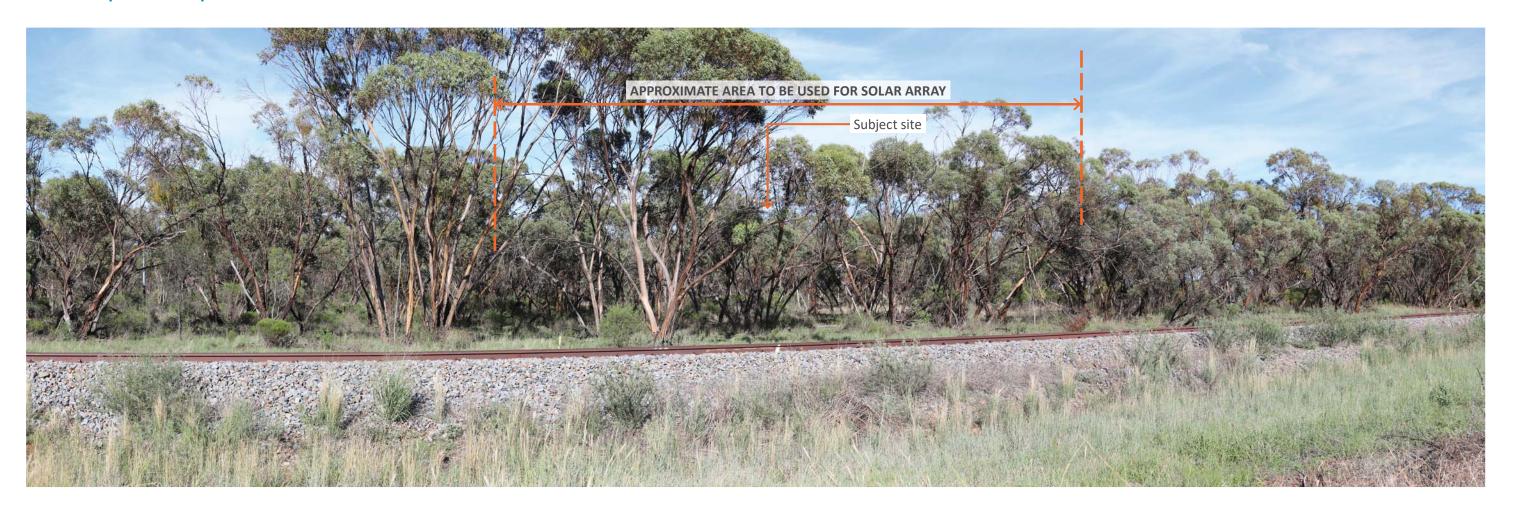
5.6.5 Viewpoint 3 - Proposed

Receptor - VP3 Summary of Impact Assessment		
Receptor Sensitivity	Negligible	
Magnitude of Landscape Change	Negligible	
Impact Significance	Negligible	
Mitigation Measures	From this viewpoint no mitigation measures are considered necessary.

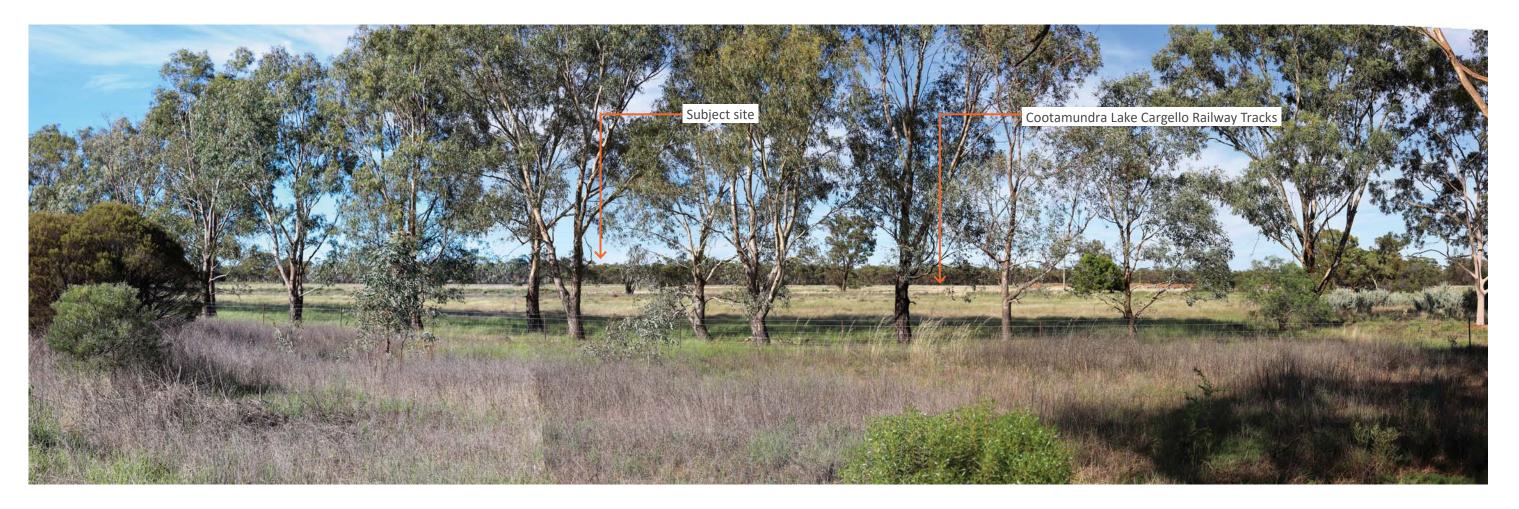
5.6.6 Viewpoint 4 - Existing

Receptor - VP4	Location	
Coordinate Location	33°55′54.498″ S 147°15′16.968″ E	
View Description	Description View looking south west towards the Solar Farm from Goldfields Way	
Distance from Site Approx. 500m

- Rural landscape dominated by boundary line vegetation in the foreground and open fields in the middle ground.
- Vegetation along the northern edge of site (background of this view) terminates views from this viewpoint.

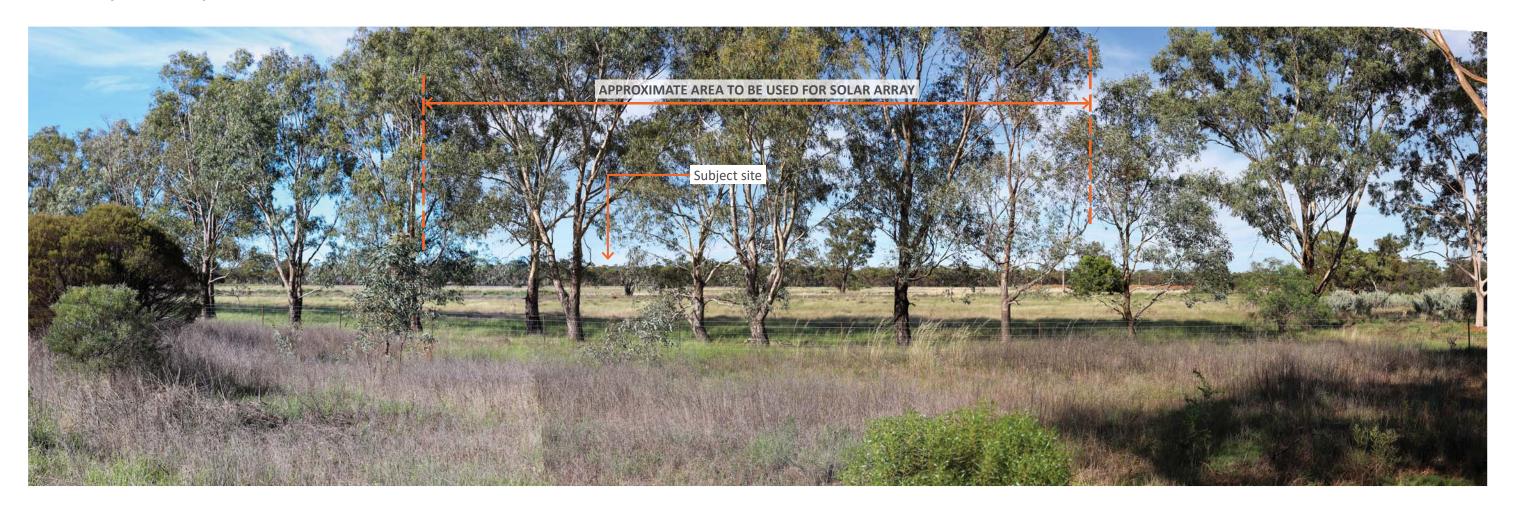
5.6.6 Viewpoint 4 - Proposed

Receptor - VP4 Summary of Impact Assessment				
Receptor Sensitivity	Negligible			
Magnitude of Landscape Change	Negligible			
Impact Significance	Negligible			
Mitigation Measures	From this viewpoint no mitigation measures are considered necessary.

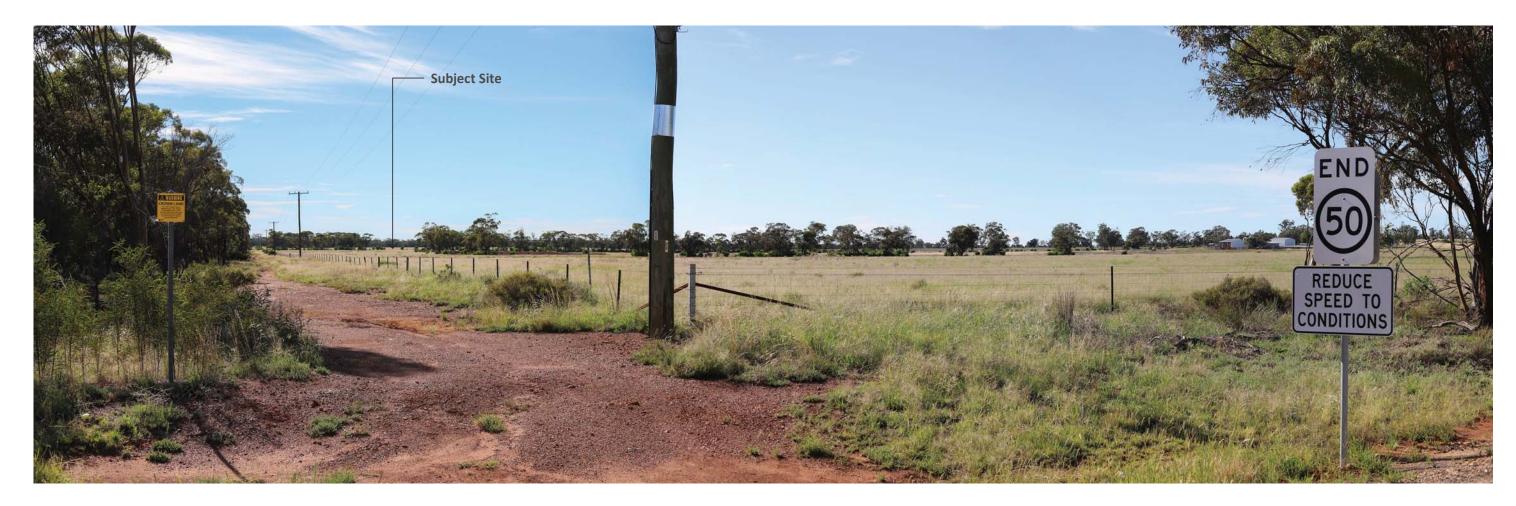
5.6.6 Viewpoint 5 - Existing

Receptor - VP5	Location	
Coordinate Location	33°56′5.076″ S 147°14′21.408″ E	
View Description	View looking east from Wargin Road	
Distance from Site	Approx. 750m

- Rural landscape dominated by open fields in the foreground. Vegetation to either side of this view is also prominent.
- Vegetation along Wargin Road and the northern edge of the site are prominent whilst views of vegetation along the boundary line in the middle ground breaks up open views.

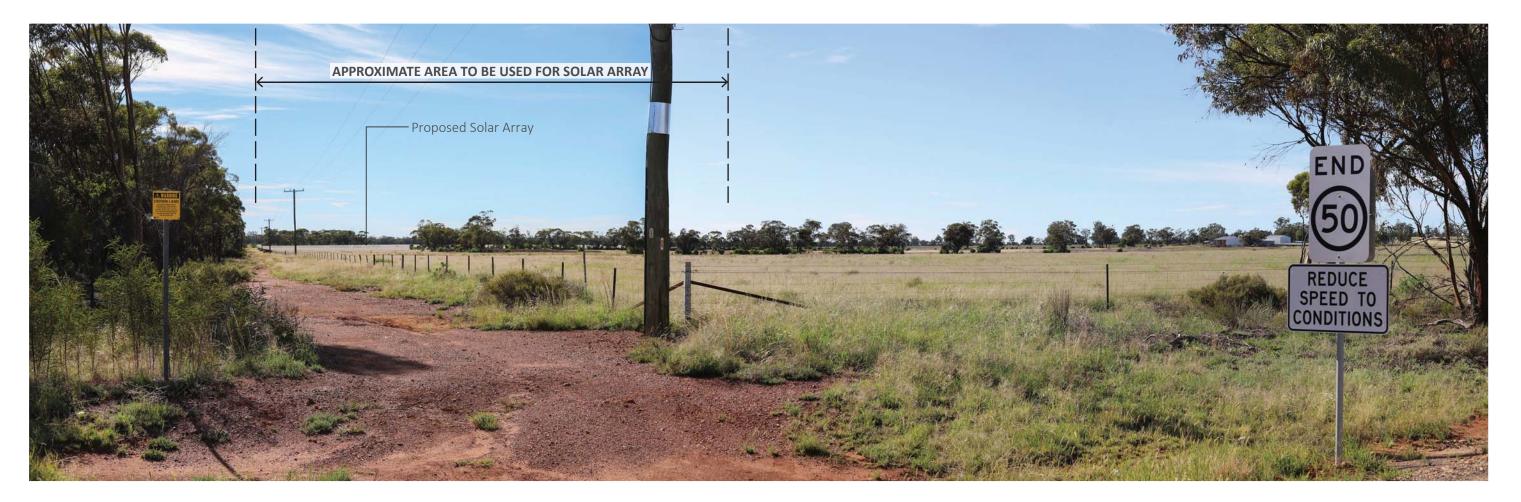
5.6.6 Viewpoint 5 - Proposed

Receptor - VP5 Summary of Impact Assessment				
Receptor Sensitivity	Negligible			
View Magnitude of Landscape Change	Low			
Impact Significance	Minor - Negligible			
Mitigation Measures	From this viewpoint no mitigation measures are considered necessary.

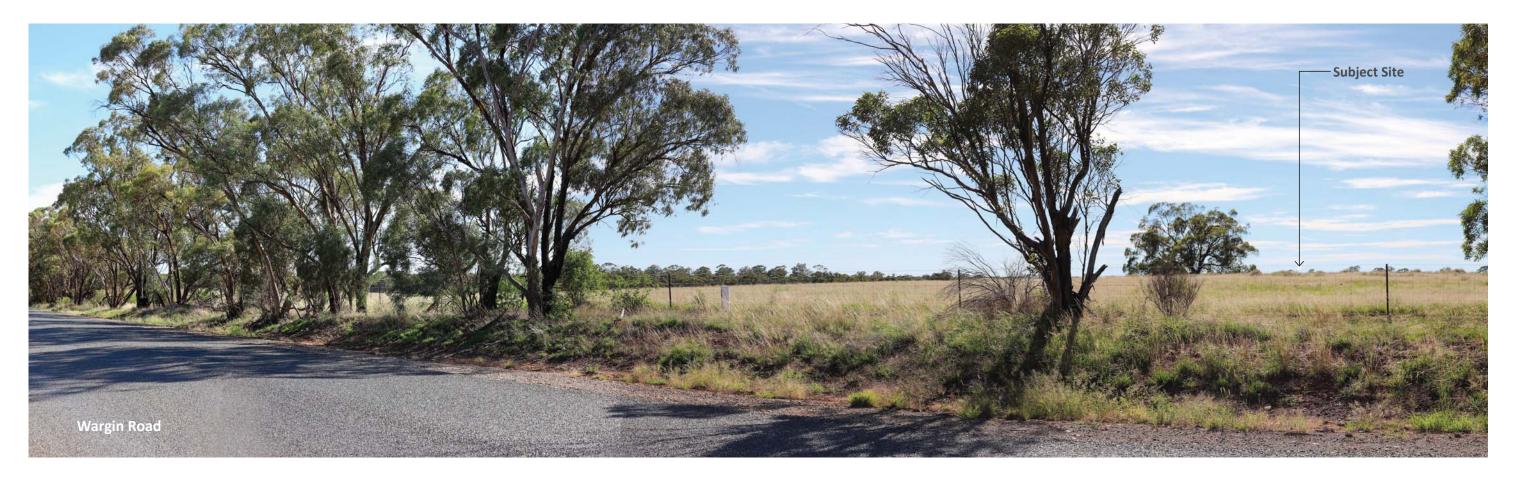
5.6.6 Viewpoint 6 - Existing

Location	
33°56′18.984″ S 147°14′19.17″ E	
View Description View looking east from Wargin Road towards the Solar Farm site	
Approx. 750m

- Rural landscape dominated by Wargin Road in the foreground.
- Vegetation along the road and northern edge of site terminates views from this viewpoint.

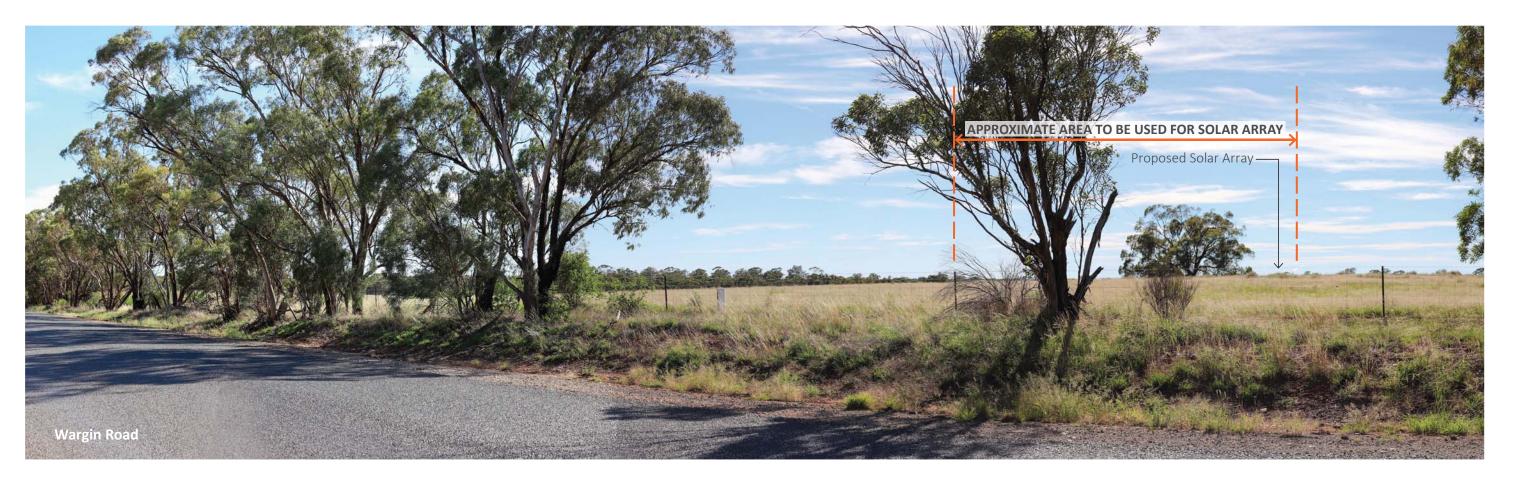
5.6.6 Viewpoint 6 - Proposed

Receptor - VP6 Summary of Impact Assessment				
Receptor Sensitivity	Negligible			
View Magnitude of Landscape Change	Negligible			
Impact Significance	Negligible			
Mitigation Measures	From this viewpoint no mitigation measures are considered necessary.
